## Accessibility Survey

### Town of Tisbury Library

200 Main Street  
Vineyard Haven, MA 02568

Date of Inspection  
4/30/2019

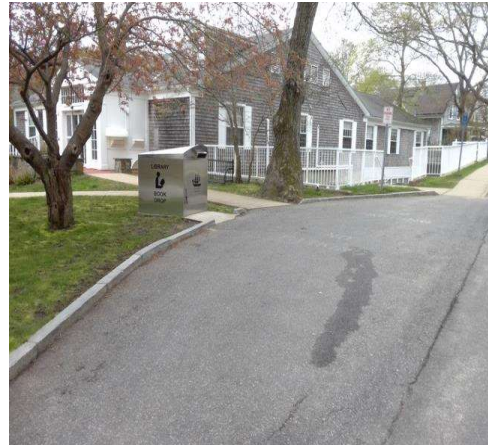
There is a change in elevation greater than recommended value.

Ensure that the change in elevation is within the recommended value.

Recommendation Up to 0.25 inches

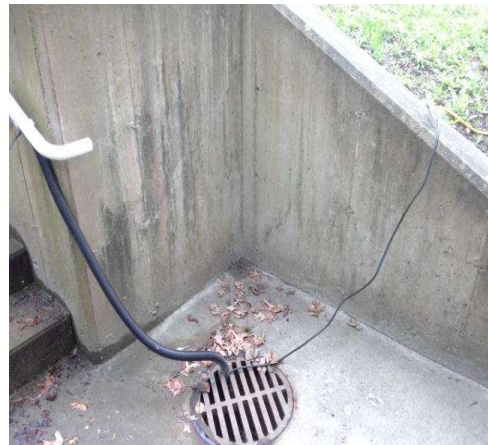
There is a change in elevation greater than recommended value.

Ensure that the change in elevation is within the recommended value.

Recommendation Up to 0.25 inches

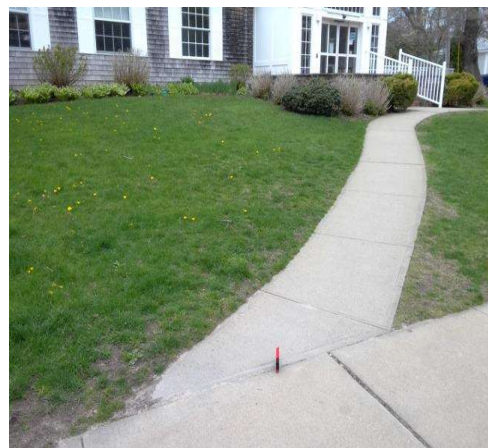
There is a change in elevation greater than recommended value.

Ensure that the change in elevation is within the recommended value.

Recommendation Up to 0.25 inches

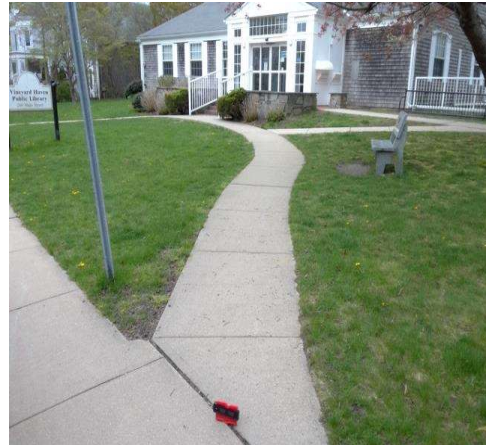
There is a change in elevation greater than recommended value.

Ensure that the change in elevation is within the recommended value.

Recommendation Up to 0.25 inches

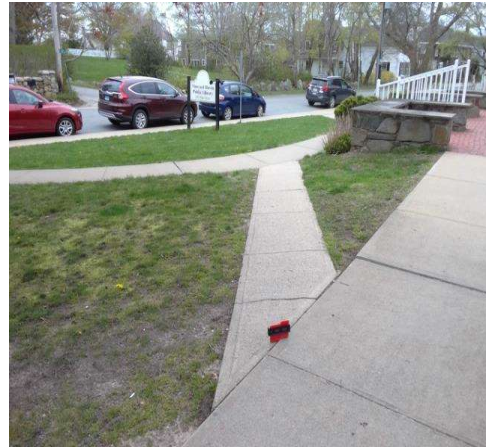
The surface of the primary accessible path of travel is rough and uneven, providing a hazardous surface for individuals with mobility impairments and the general public.

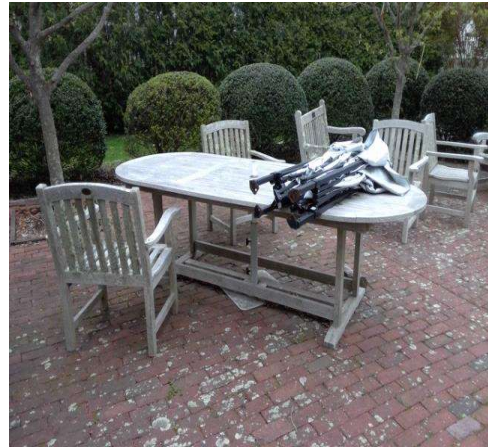
Bench : On Accessible Route

The bench is not on an accessible route.

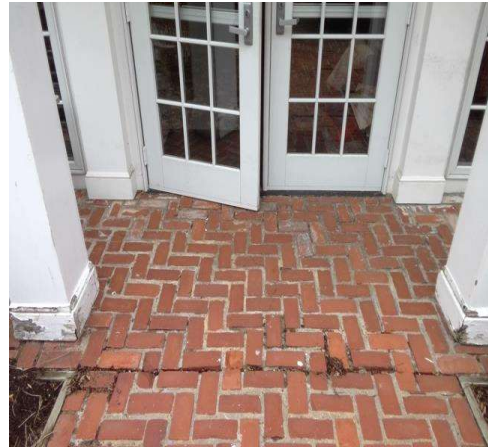
The bottom of the door does not provide a smooth, uninterrupted surface, or panel to allow the door to be opened by a wheelchair footrest without creating a trap or hazardous condition.

Install a panel or replace the door to provide a smooth, uninterrupted surface at the bottom of the door.

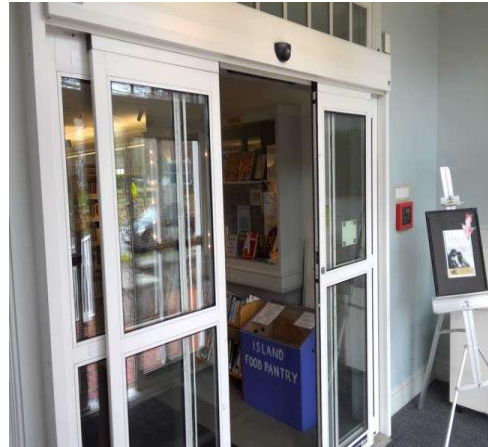
Signage , Signage : No Accessible  
Element/Entrance Signage

There is no room signage.
