## Accessibility Survey

### Town of Tisbury Library

200 Main Street  
Vineyard Haven, MA 02568

Date of Inspection  
4/30/2019

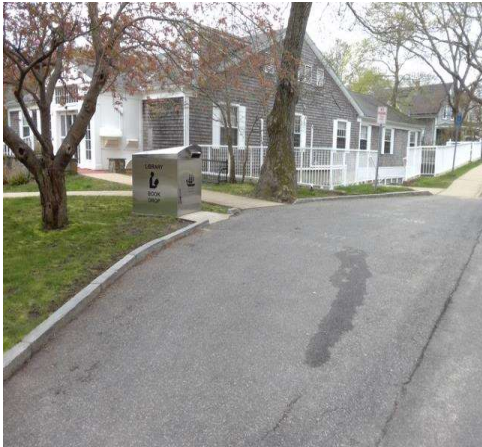
Passenger Loading Zone : No Sign

Passenger loading zone has no sign.

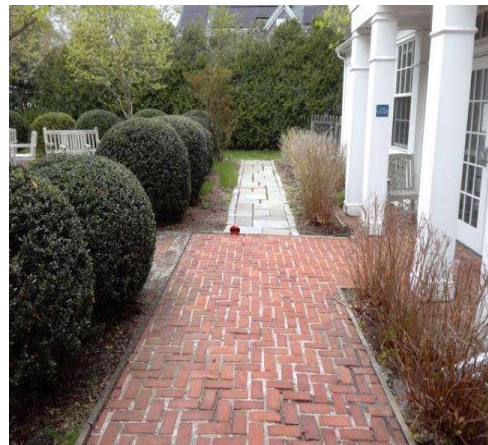
There is a change in elevation greater than recommended value.

Ensure that the change in elevation is within the recommended value.

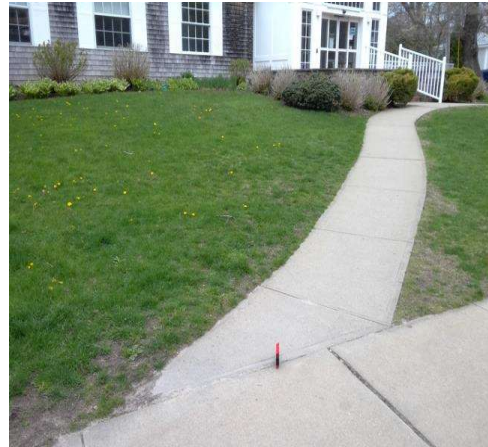
There is a change in elevation greater than recommended value.

Ensure that the change in elevation is within the recommended value.

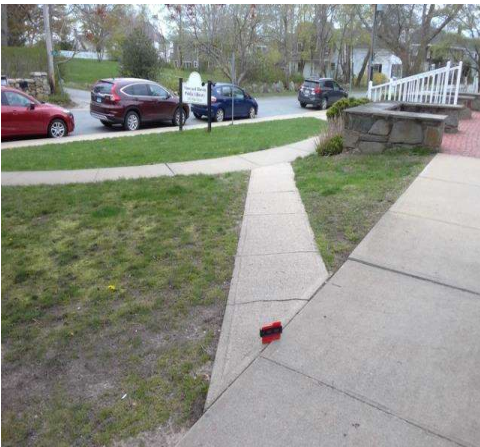
There is a change in elevation greater than recommended value.

Ensure that the change in elevation is within the recommended value.

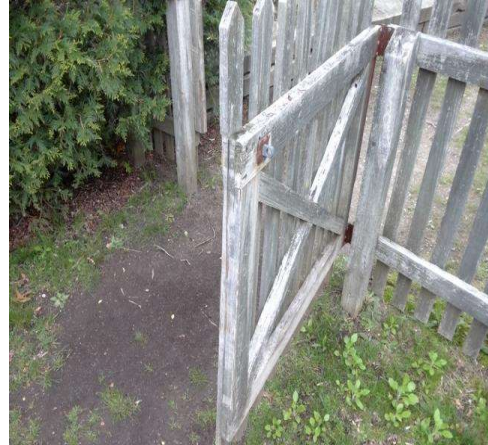
The bottom of the door does not provide a smooth, uninterrupted surface, or panel to allow the door to be opened by a wheelchair footrest without creating a trap or hazardous condition.

Install a panel or replace the door to provide a smooth, uninterrupted surface at the bottom of the door.

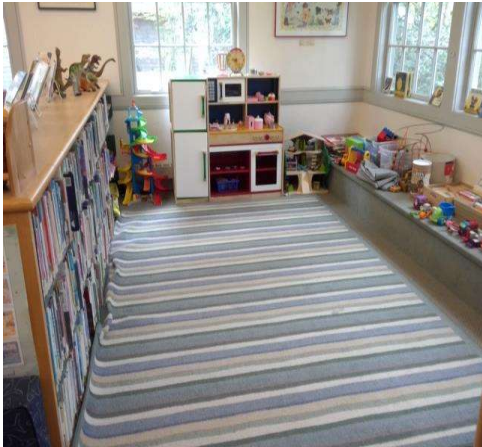
The mats or carpet runners do not adhere to the underlying floor surface and slip, thereby creating a hazardous path of travel.

Securely fasten the mats or carpet runners or replace with a mat or carpet runner that grips to the underlying floor surface to provide a firm, stable, continuous and relatively smooth path of travel surface. Mats or carpet runners along the primary path of travel shall provide beveled edges on all sides to prevent roll over.

Install mat or carpet runner that grips to the underlying floor surface \$126

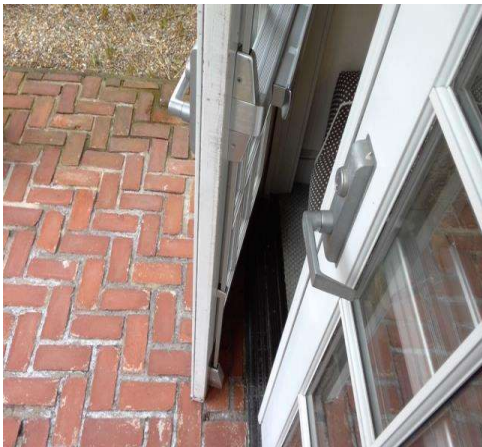
The bottom of the door does not provide a smooth, uninterrupted surface, or panel to allow the door to be opened by a wheelchair footrest without creating a trap or hazardous condition.

Install a panel or replace the door to provide a smooth, uninterrupted surface at the bottom of the door.

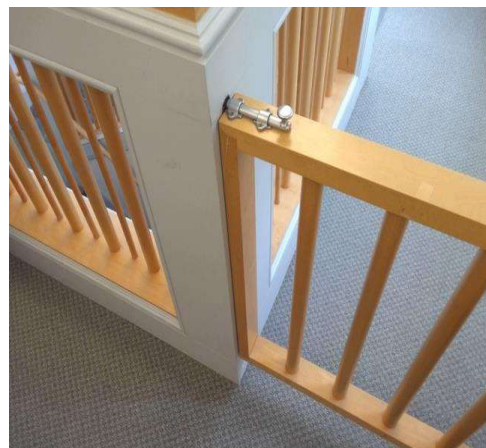
The bottom of the door does not provide a smooth, uninterrupted surface, or panel to allow the door to be opened by a wheelchair footrest without creating a trap or hazardous condition.

Install a panel or replace the door to provide a smooth, uninterrupted surface at the bottom of the door.

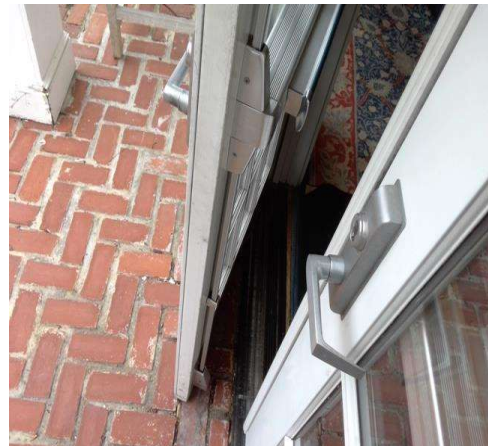
The bottom of the door does not provide a smooth, uninterrupted surface, or panel to allow the door to be opened by a wheelchair footrest without creating a trap or hazardous condition.

Install a panel or replace the door to provide a smooth, uninterrupted surface at the bottom of the door.

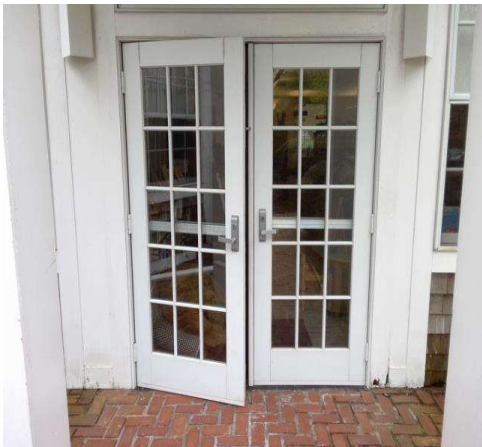
**On-Site Finding** None Found

**Code Reference** MA 41.1, ADA 703, 216, 216.2

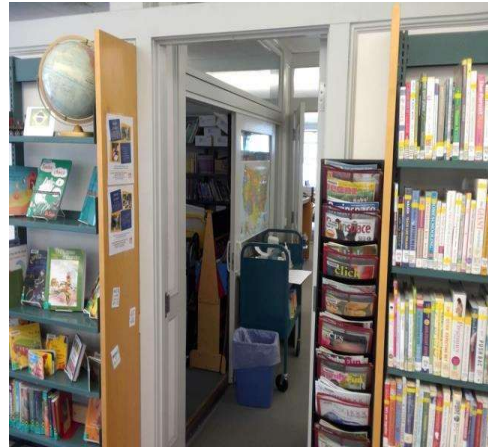
## 1st Floor Staff Area Office

**On-Site Finding**    None Found

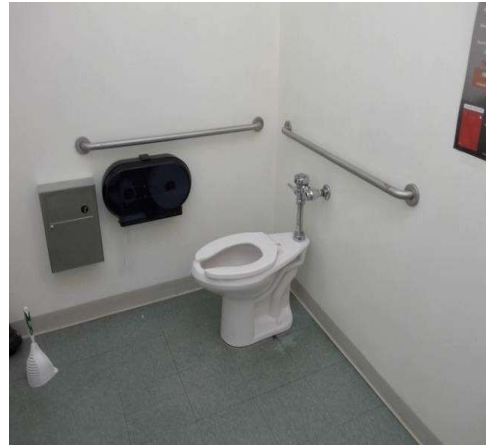
### Restrooms - Library : Restroom , Toilet Compartment

Mount the coat hook at the recommended height.

Recommendation 15.00 - 48.00 inches

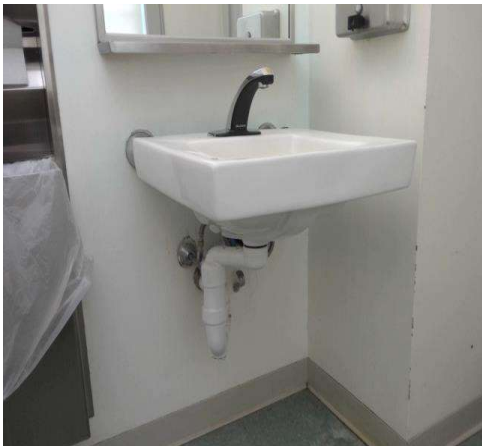
### Restrooms - Library : Restroom , Mirror

Lower the mirror so the bottom edge of the reflective surface is no higher than recommended above the finished floor.

Recommendation Up to 40.00 inches

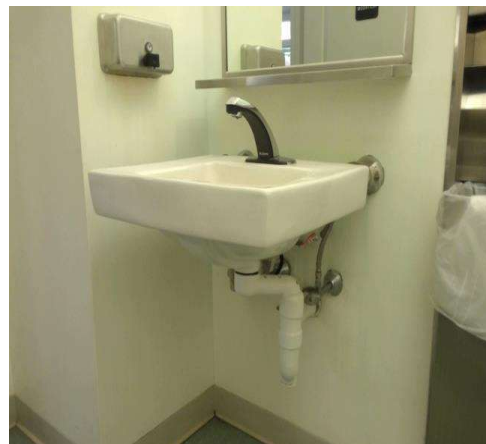
### Restrooms - Library : Restroom , Mirror

Lower the mirror so the bottom edge of the reflective surface is no higher than recommended above the finished floor.

Recommendation Up to 40.00 inches

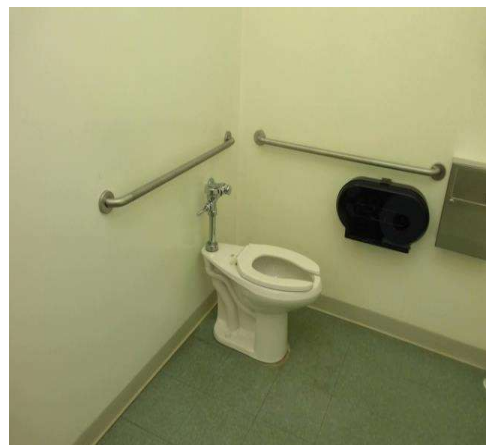
**Restrooms - Library : Restroom , Toilet Compartment**

Mount the coat hook at the recommended height.

Recommendation 15.00 - 48.00 inches

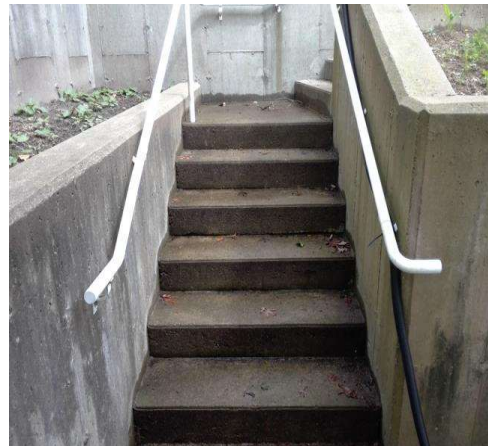
**Record Number** 51099

**Code Reference** MA 27.4.2, ADA 504, 504.6, 505.4

Recommendation 34.00 - 38.00 inches

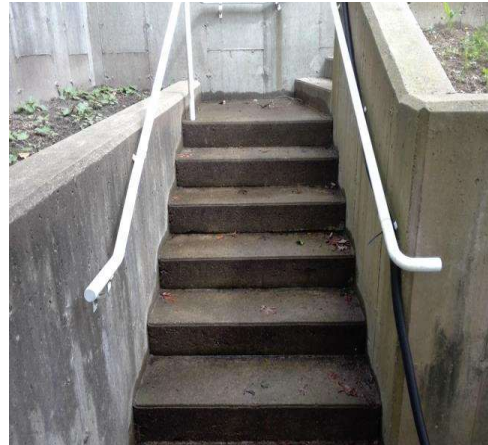
**Record Number** 51095

### Stairs - Lower Level : Stairway , Handrails

**On-Site Finding** None Found

Recommendation See Recommendation

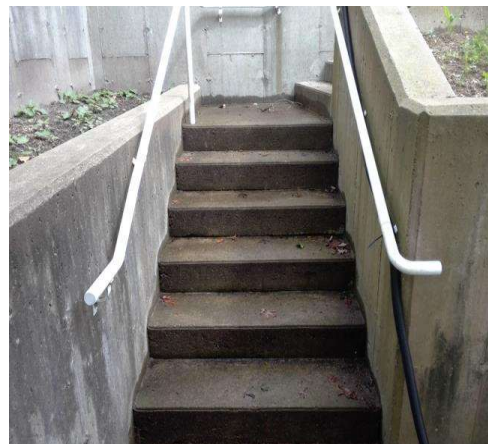
**Record Number** 51096

### Stairs - Lower Level : Stairway , Handrail

**On-Site Finding** None Found

Recommendation See Recommendation

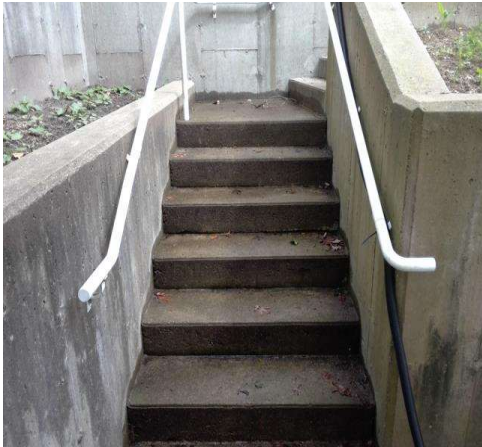
**Record Number** 51097

**Stairs - Lower Level : Stairway , Handrails**

Recommendation 34.00 - 38.00 inches

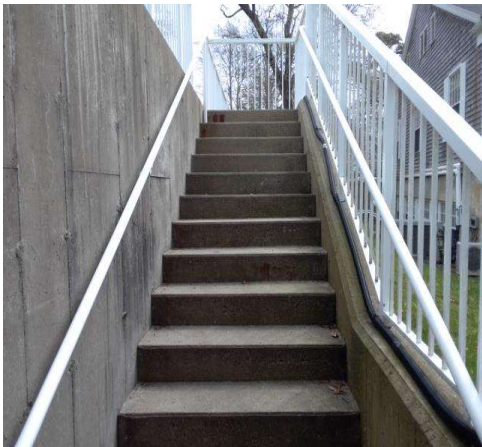
**Record Number** 51100

**Stairs - Lower Level : Stairway , Handrails**

**On-Site Finding** None Found

Recommendation See Recommendation

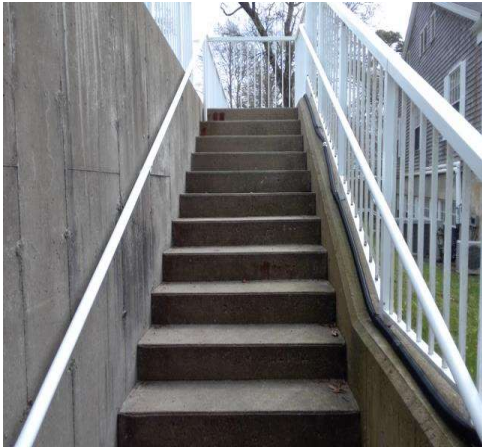
**Record Number** 51101

**Stairs - Lower Level : Stairway , Handrails**

Recommendation 34.00 - 38.00 inches

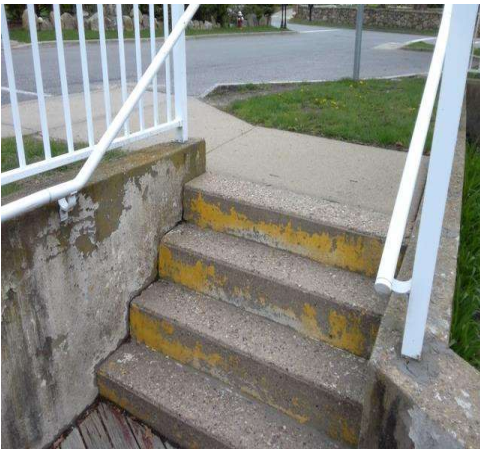
**Record Number** 51110

**Stairs - Lower Level : Stairway , Risers**

Modify or replace the stairs to provide uniform riser height.

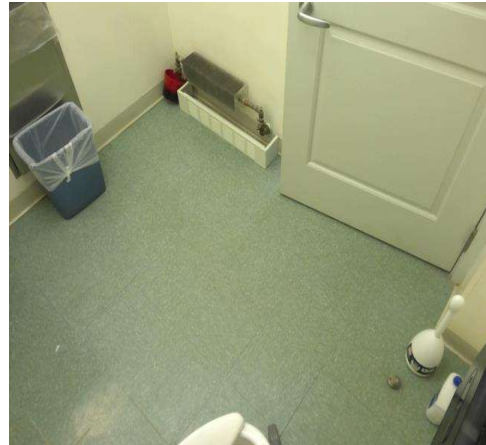
**Record Number** 51140

### Doors - Lower Level : Door , Clear Floor Space

Notes : Toilet Obstructs Clear Floor Space Length.

Provide the recommended clear floor space on the pull side of the door.

Recommendation At least 60.00 inches

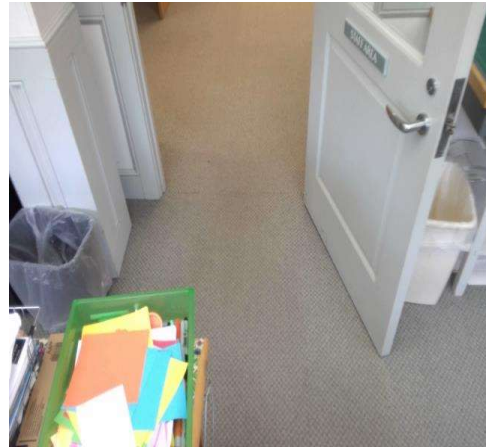
**Record Number** 50931

### Doors - Lower Level : Door , Latch Side Clearance

Notes : Pillar Obstructs Latch Side Clearance.

Recommendation At least 18.00 inches

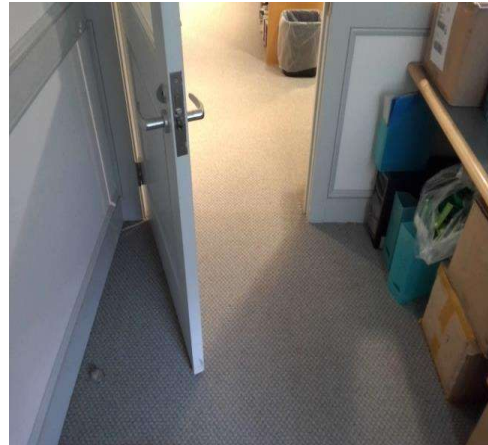
**Record Number** 50915

### Doors - Lower Level : Door , Latch Side Clearance

Notes : Table Obstructs Latch Side Clearance.

Recommendation At least 18.00 inches

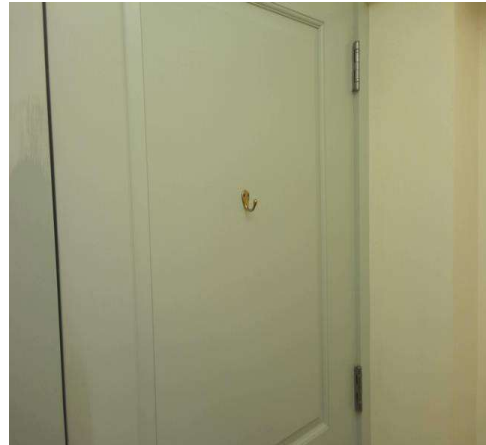
**Record Number** 51163

### Restrooms - Lower Level : Restroom , Toilet Compartment

Mount the coat hook at the recommended height.

Recommendation 15.00 - 48.00 inches

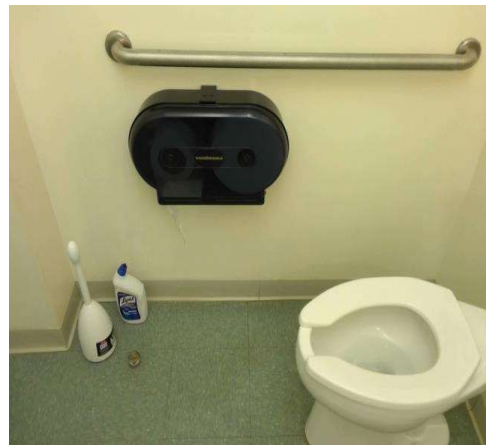
**Record Number** 51164

### Restrooms - Lower Level : Restroom , Toilet Compartment

Recommendation 7.00 - 9.00 inches

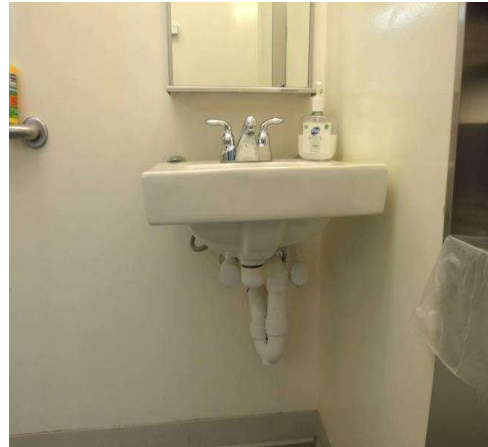
**Record Number** 51175

**Code Reference** MA 30.9.2, ADA 213, 606, 606.3

##### Recommendation

Relocate or replace the lavatory to provide a maximum counter surface height of no greater than recommended.

Recommendation Up to 34.00 inches

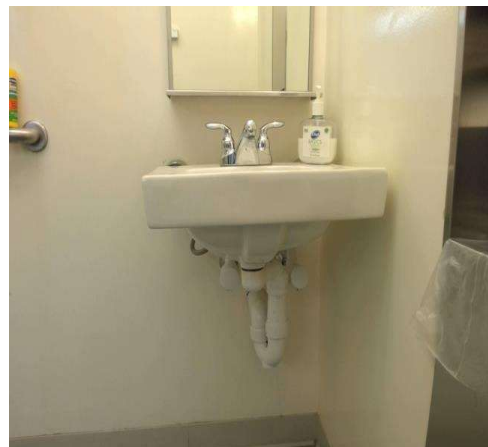
**Record Number** 51176

### Restrooms - Lower Level : Restroom , Lavatory

**Code Reference** MA 30.9.5, ADA 213, 606, 606.5

##### Recommendation

Recommendation See Recommendation

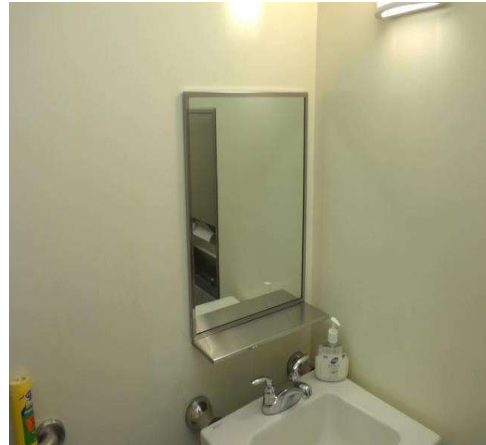
**Record Number** 51177

### Restrooms - Lower Level : Restroom , Mirror

**Code Reference** MA 30.11, ADA 603, 213, 603.3

##### Recommendation

Lower the mirror so the bottom edge of the reflective surface is no higher than recommended above the finished floor.

Recommendation Up to 40.00 inches

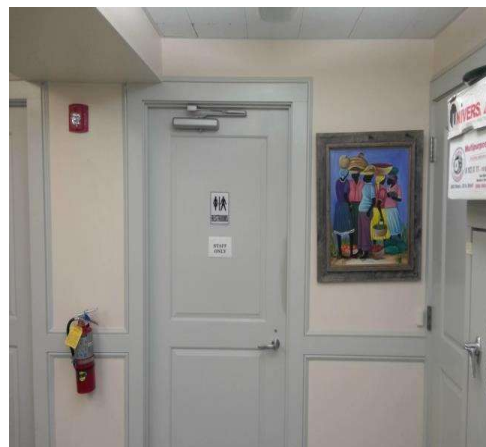
**Record Number** 51178

### Restrooms - Lower Level : Restroom , Wall Signage

**Code Reference** MA 41.1, ADA 703, 216, 216.8

##### Recommendation

Recommendation See Recommendation

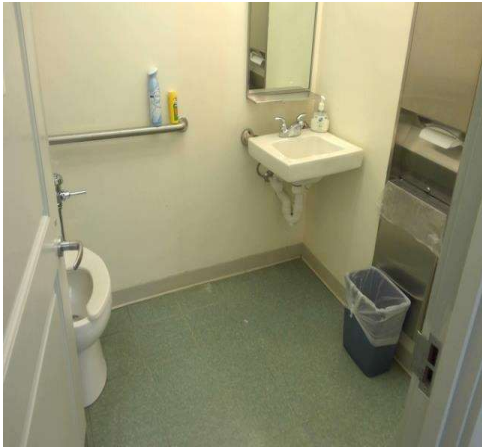
**Record Number** 51172

**Restrooms - Lower Level : Restroom**

**Code Reference** ADA 213, 213.2.1

**Recommendation**

Recommendation See Recommendation

Replace existing lock set with lever handled lock set \$804

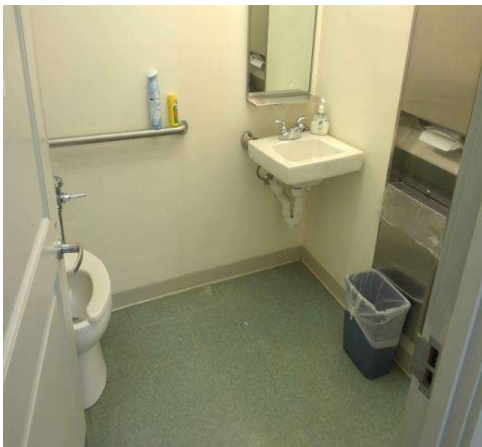
**Record Number** 51173

**Restrooms - Lower Level : Restroom**

**Code Reference** ADA 603, 304, 304.3.1, 603.2.1, 304.3

**Recommendation**

Recommendation At least 60.00 inches

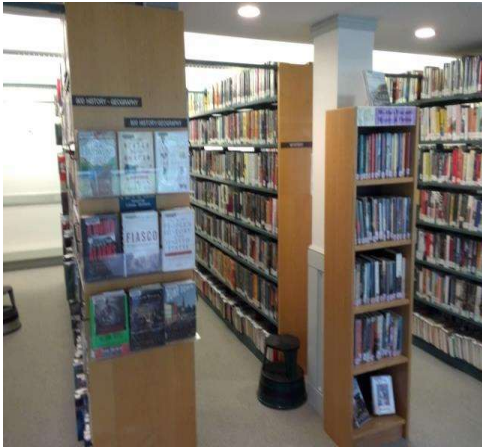
**Record Number** 50916

**Libraries - Lower Level : Library , Aisles**

**Code Reference** ADA 403

**Recommendation**

Increase the space between shelves to the recommended value.

Recommendation At least 42.00 inches

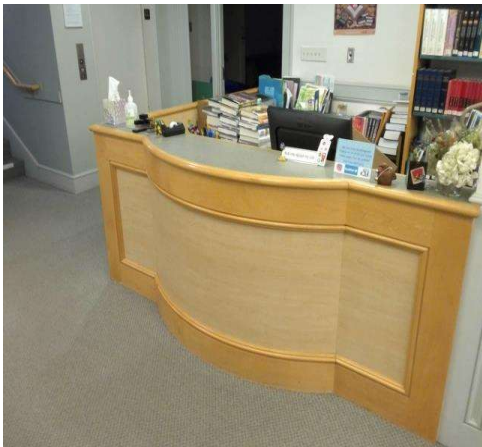
**Record Number** 50919

**Libraries - Lower Level : Library , Checkout Counter**

**Code Reference** MA 12.2.3, ADA 904, 227

**Recommendation**

Recommendation 28.00 - 34.00 inches

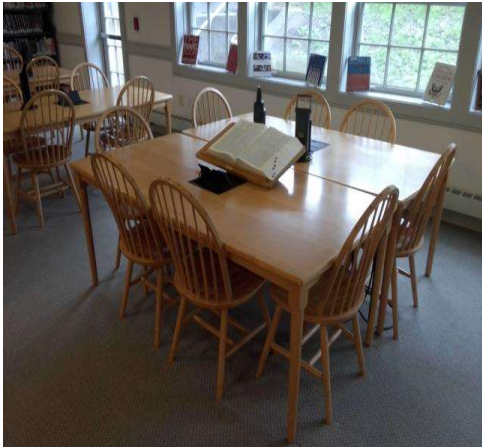
**Record Number** 50921

**Libraries - Lower Level : Library , Table**

**Code Reference** ADA 306, 902, 226, 902.2

**Recommendation**

Recommendation At least 27.00 inches

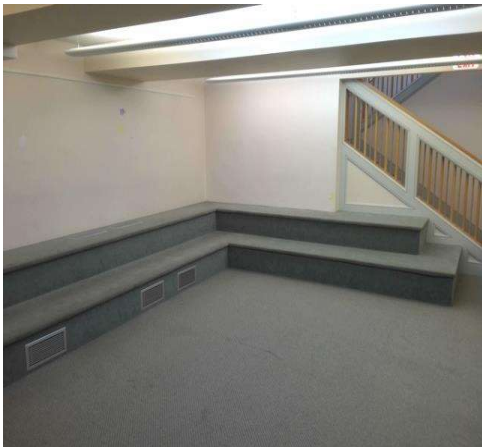
**Record Number** 50875

**Assembly Areas - Lower Level : Assembly Area**

**Code Reference** ADA 221.2, 802.1

**Recommendation**

Recommendation At least 2.00 seats

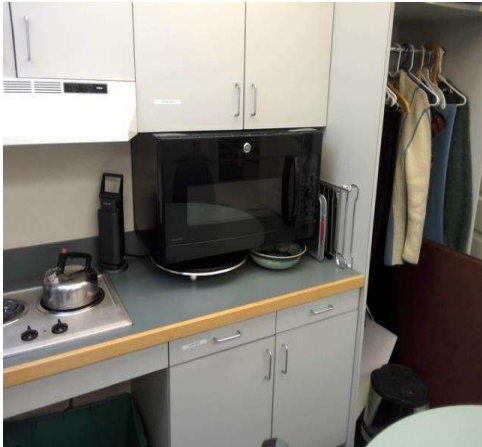
**Record Number** 51079

**Break/Conference Room - Lower Level : Break Room , Appliance**

**Code Reference** ADA 309, 205, 308

**Recommendation**

Recommendation Up to 48.00 inches

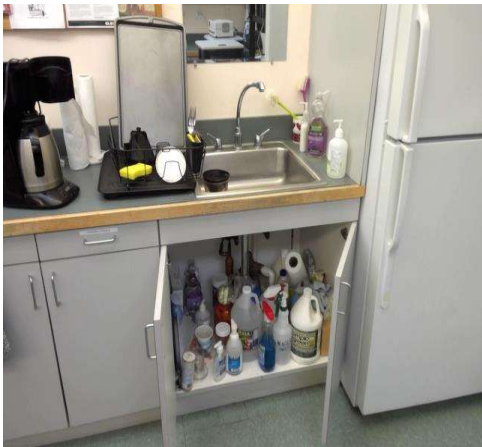
**Record Number** 51075

**Break/Conference Room - Lower Level : Break Room**

**Code Reference** ADA 606.3

**Recommendation**

Recommendation Up to 34.00 inches

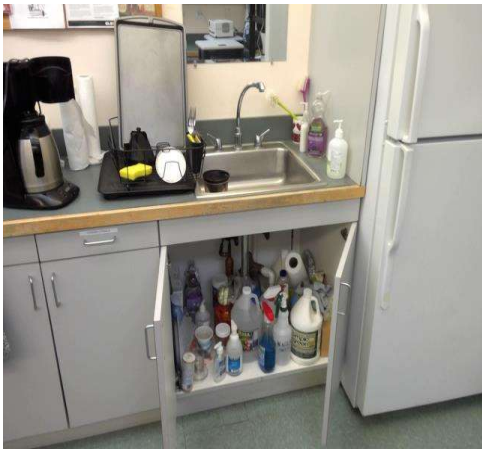
**Record Number** 51076

**Break/Conference Room - Lower Level : Break Room**

**Code Reference** ADA 606.5

**Recommendation**

Recommendation See Recommendation

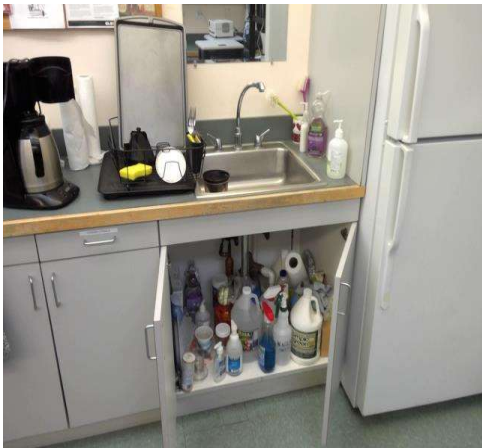
**Record Number** 51077

**Break/Conference Room - Lower Level : Break Room**

**Code Reference** ADA 305, 306, 606.2

**Recommendation**

Recommendation See Recommendation

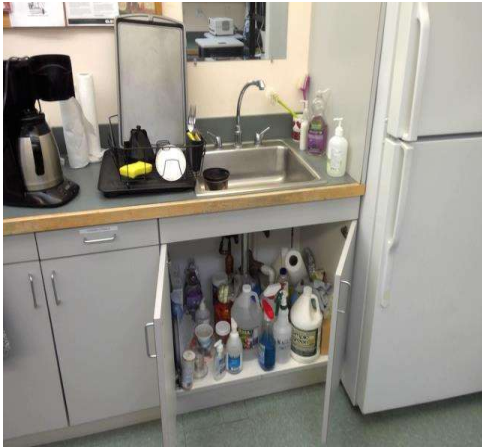
**Record Number** 51078

**Break/Conference Room - Lower Level : Break Room , Sink**

**Code Reference** ADA 606.5

**Recommendation**

Recommendation See Recommendation

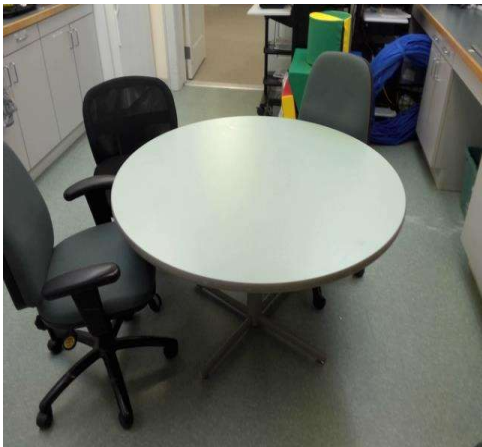
**Record Number** 51073

**Break/Conference Room - Lower Level : Break Room**

Notes : Table is Not Accessible By Design.

**Recommendation**

Recommendation At least 27.00 inches

Adjust/Replace Table \$500

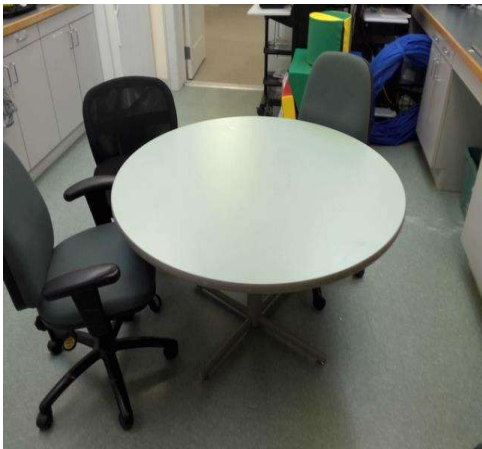
**Record Number** 51074

**Break/Conference Room - Lower Level : Break Room**

Notes : Table is Not Accessible By Design.

**Recommendation**

Recommendation At least 19.00 inches

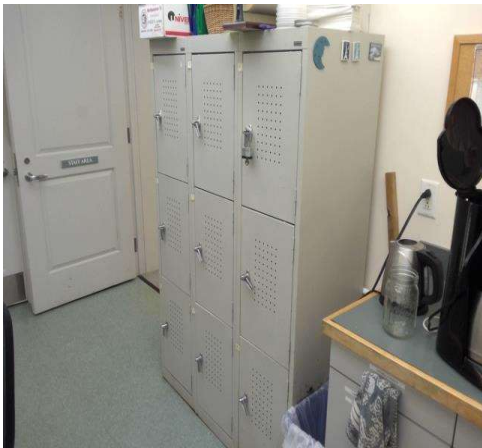
**Record Number** 51156

**Lockers - Lower Level : Lockers**

No accessible lockers were found.

**Code Reference** ADA 225.2.1, 811

**Recommendation**

Recommendation See Recommendation
